AIR TRANSPORTATION SAFETY INVESTIGATION REPORT A17Q0030

MID-AIR COLLISION

Cargair Ltd., Cessna 152, C-GPNP
and
Cargair Ltd., Cessna 152, C-FGOI
Montréal/St-Hubert Airport, Quebec, 1.7 nm ESE
17 March 2017

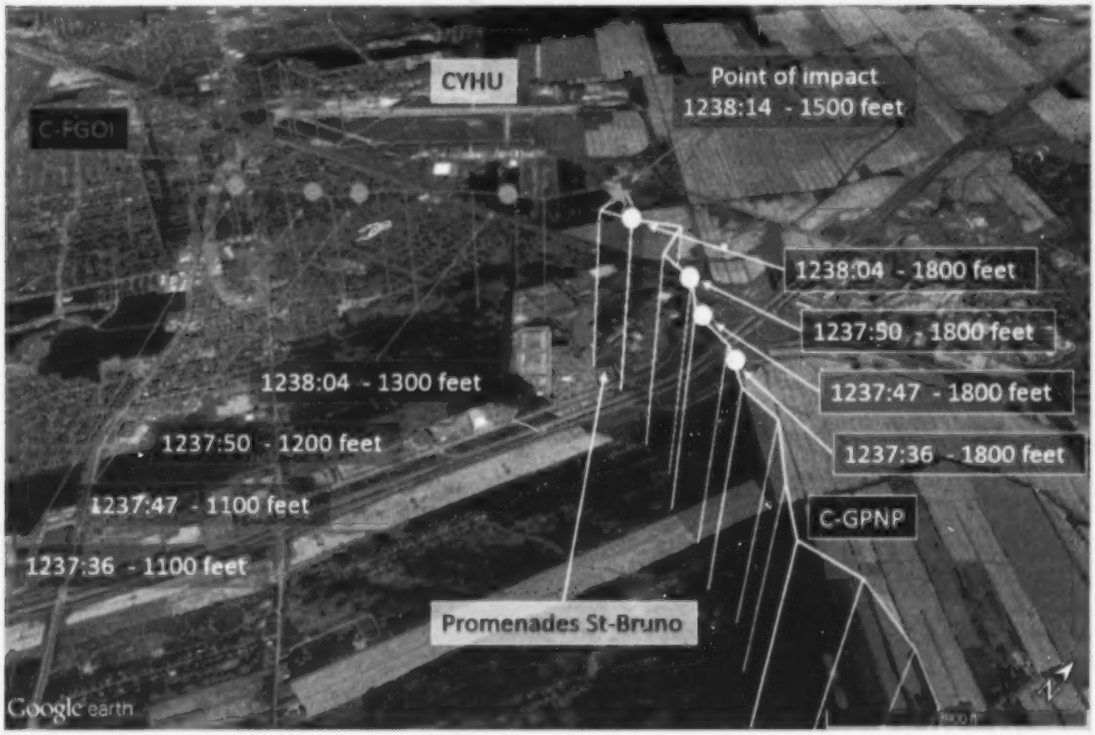
Figure 1. Flight paths of C-FGOI and C-GPNP (Source: Google Earth, with TSB annotations)

At 1237:36, the tower controller provided C-GPNP with traffic information[3] about C-FGOI.[4] The 2 aircraft were approximately 1.8 nm apart; C-GPNP was inbound from the southeast at 1800 feet ASL, and C-FGOI was at 1100 feet ASL on an east-northeast heading (Figure 1). When the controller had heard no acknowledgment from C-GPNP of the traffic information after 11 seconds, the controller repeated the transmission. The distance between the 2 aircraft had narrowed to 1.3 nm: the radar display showed C-GPNP at 1800 feet ASL and C-FGOI at 1100 feet ASL.

At 1238:04, the tower controller made a further attempt to communicate with C-GPNP, and again heard no reply. C-GPNP and C-FGOI were now approximately 0.5 nm apart; the radar display showed that C-GPNP was at 1800 feet ASL, while C-FGOI had begun climbing and was at 1300 feet ASL.

When the pilot of C-GPNP realized that the tower controller could not hear his responses, he began to troubleshoot the aircraft's radiocommunication system, and the aircraft descended below 1600 feet. By the time he saw C-FGOI, the impact was imminent and the collision could not be avoided.

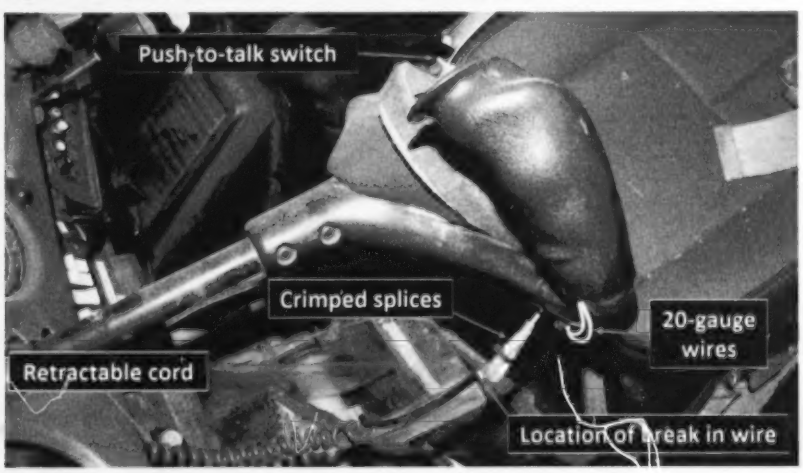
Figure 6. C-GPNP's push-to-talk switch installation

The aircraft's NAV/COM VHF transmitter/receiver and accompanying intercom system were examined for defects to determine the cause of the intermittency of the radio's transmissions. The pilot side of the cockpit was fitted with a handset, which was slipped over the aircraft's control yoke and included the intercom's PTT switch at the top. Tests conducted on the pilot PTT switch showed that it was necessary to depress the switch twice for the radio to be triggered into transmission mode. Further, movement of the control yoke caused transmissions to be intermittent.

The examination found that the retractable cord connecting the switch to the intercom was routed through terminals at the back of the pilot-side microphone and headset jack panel. Further examination of the PTT switch revealed a defect that originated from pre-existing crimped wire splices located just forward of the control yoke. The splices connected the wires running from the grip of the control-yoke handset to those in the retractable cord (Figure 6). The wire splices and adjoining wires were unsupported and had been left to hang, and were therefore bearing all motion and tension loads. The retractable cord was not secured to the control yoke.

The examination of C-GPNP's radiocommunication system demonstrated that the pilot-side (left) push-to-talk (PTT) switch had to be depressed twice to key the radio into transmission mode, and that movement of the control yoke caused transmissions to be intermittent. This was found to originate from pre-existing wire splices located just forward of the control yoke.

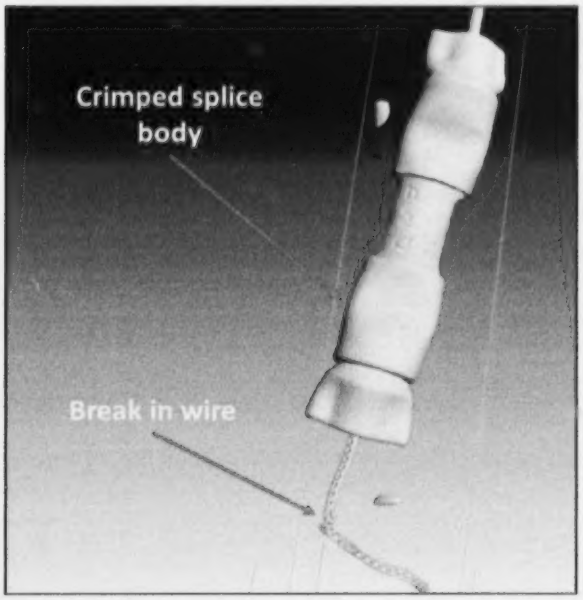
Figure 7. Computed tomography scan view of the broken wire

It was determined that the intermittency of the radio's transmissions was likely caused by the break found in one of the wires of the retractable cord, adjacent to the crimped splice. A detailed examination of the broken wire identified distinct necking (a localized narrowing resulting from reduction in the strand cross-section) at the location of the break. Necking at the point of a rupture is seen when wires have failed in overload due to disproportionately applied tensile loads (Figure 7 and Figure 8).

Further examination revealed a break in a wire within the retractable cord of the pilot's PTT. It was also determined that the support provided to the wire splices and adjacent wires was inadequate for their location and intended use, and likely contributed to the break. A broken wire caused the PTT keying signal on C-GPNP's radiocommunication system to transmit intermittently prior to entering the control zone and immediately preceding the collision.

3. A broken wire caused the push-to-talk keying signal on C-GPNP's radiocommunication system to transmit intermittently prior to entering the control zone and immediately preceding the collision.

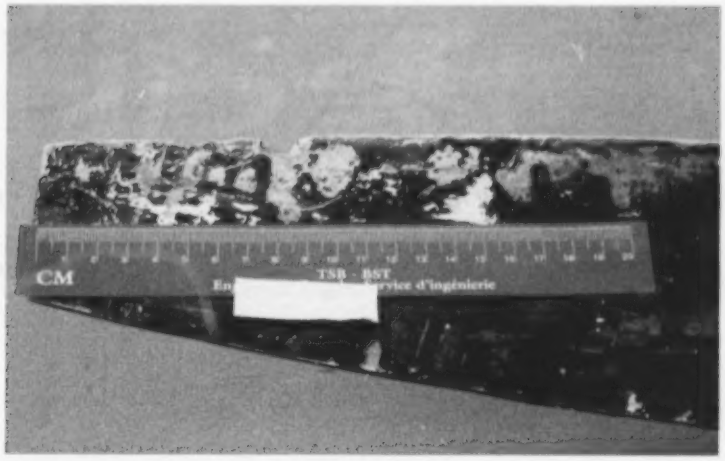
Figure 9. Impact dents on blade 1 of C-FGOI's propeller

Examination of C-FGOI's 2-bladed propeller showed impact dents on the leading edges of both blades, near their tips. The dents were consistent with the propeller blades cutting through a strong structure, such as the lower cap of C-GPNP's left-wing rear spar (Figure 9 and Figure 10).

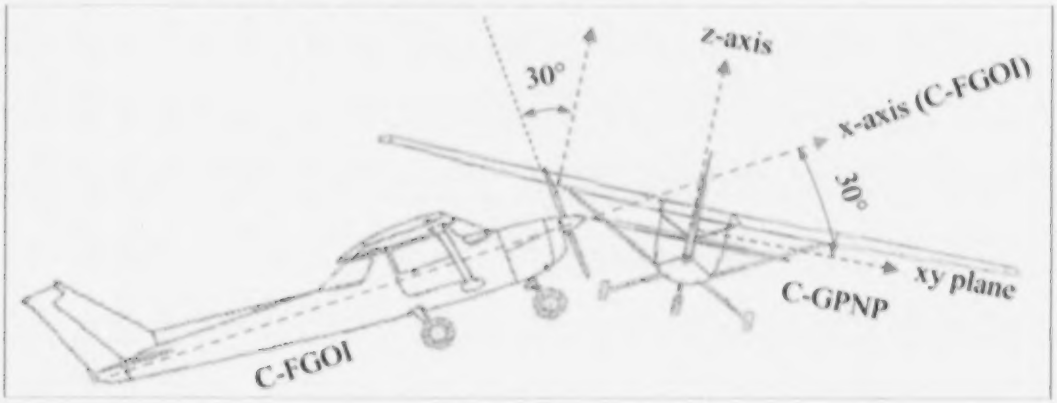
The laboratory examination established that, as the 2 aircraft collided, C-FGOI's propeller came into contact with the bottom surface of C-GPNP's left wing, rendering 3 cuts to the wing. One cut, made just forward of the left-wing rear spar, near the inboard end of the aileron of C-GPNP, appeared to be the first point of contact between the 2 aircraft. This damage was consistent with a cut from the bottom upward, indicating that C-FGOI approached C-GPNP from below.

Further analysis established that C-FGOI was likely pitching nose-up while C-GPNP made a right banking turn in an effort to avoid the collision (Figure 11).

Figure 11. Illustration of the geometric relationship between the angle of the cut to C-GPNP's wing and the comparative attitudes of the 2 aircraft (relative to C-GPNP's z-axis)

Analysis of the damage to the aircraft indicated that C-FGOI was climbing at the time of the collision. The relative attitudes of the 2 aircraft suggest that when the pilot of C-GPNP became aware of the impending collision with C-FGOI, which was approaching from the left, he made a right turn in an effort to avoid it.

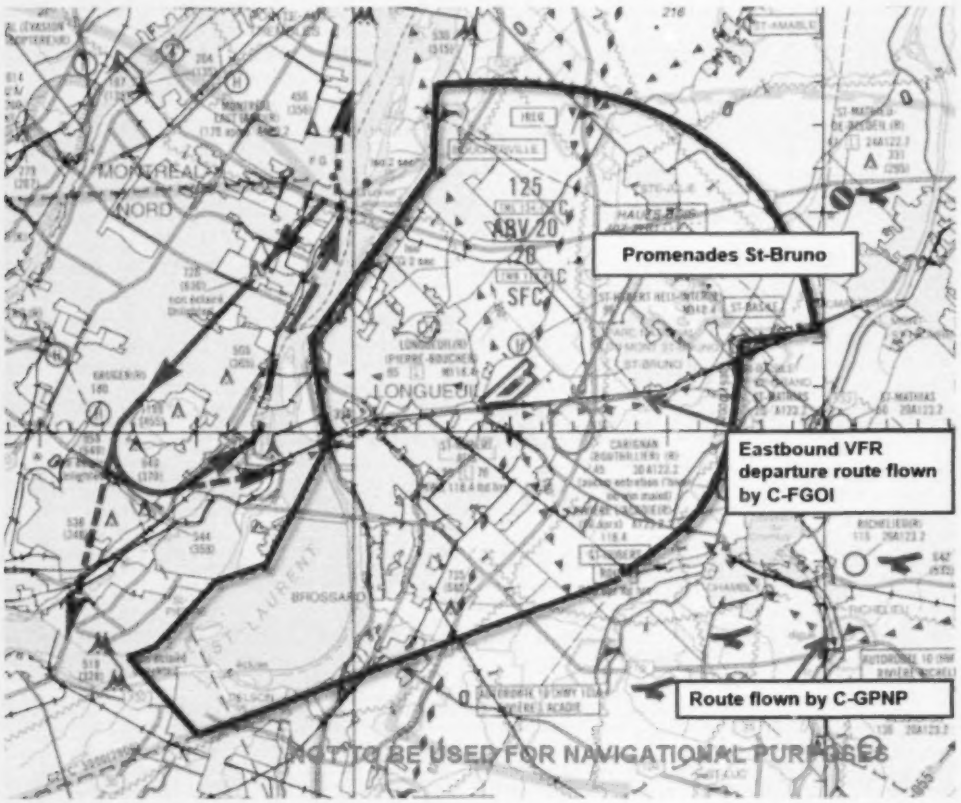
Figure 12. St-Hubert control zone (shown in blue) and surrounding area (Source: NAV CANADA, Manuel d'exploitation d'unité – Tour de St-Hubert, with TSB annotations)

NAV CANADA provides airport control services at CYHU within a 5 nm, irregularly shaped Class C[20] control zone,[21] which extends vertically to an altitude of 2000 feet ASL (Figure 12).

Promenades St-Bruno
Eastbound VFR departure route flown by C-FGOI
Route flown by C-GPNP
NOT TO BE USED FOR NAVIGATIONAL PURPOSES
